**NATIONAL TRANSPORTATION SAFETY BOARD
OFFICE OF RAILROAD, PIPELINE AND
HAZARDOUS MATERIALS INVESTIGATIONS
WASHINGTON, D.C. 20594**

FACTUAL REPORT

Accident Type: Derailment
Date and Time: September 19, 2015 at 6:18 a.m. CDT
Location: Lesterville, South Dakota
Vehicle No: BNSF train GMNXDPK7-17
Fatalities: 0
Injuries: 0
NTSB #: DCA15FR016

TRACK & ENGINEERING GROUP

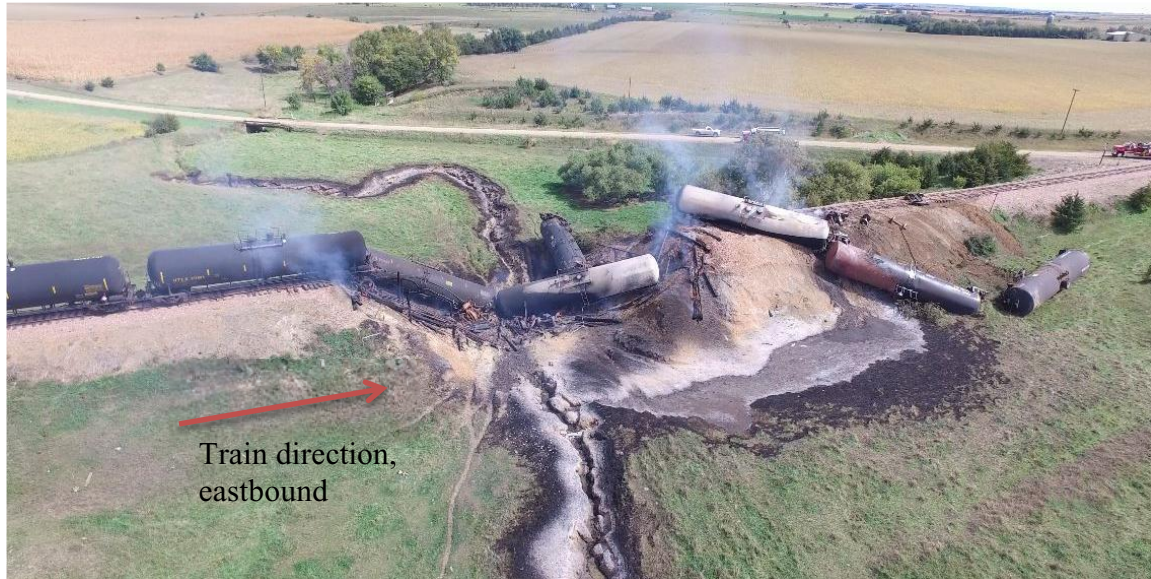
Figure 1
Aerial View of Derailment Site

On September 19, 2015, about 6:18 a.m. central daylight time, a BNSF freight train G MNXDPK7 17 (a unit ethanol train with 3 locomotives and 98 tank cars) derailed at a small bridge near Lesterville, South Dakota. Seven cars derailed, starting with the second car in the train. Three of the derailed cars released product and caught fire. There were no injuries and no evacuations were necessary. Weather was foggy with poor visibility and approximately 50° F. Estimated damage was \$1.1 million. See figure 1 for an aerial view of the accident site.

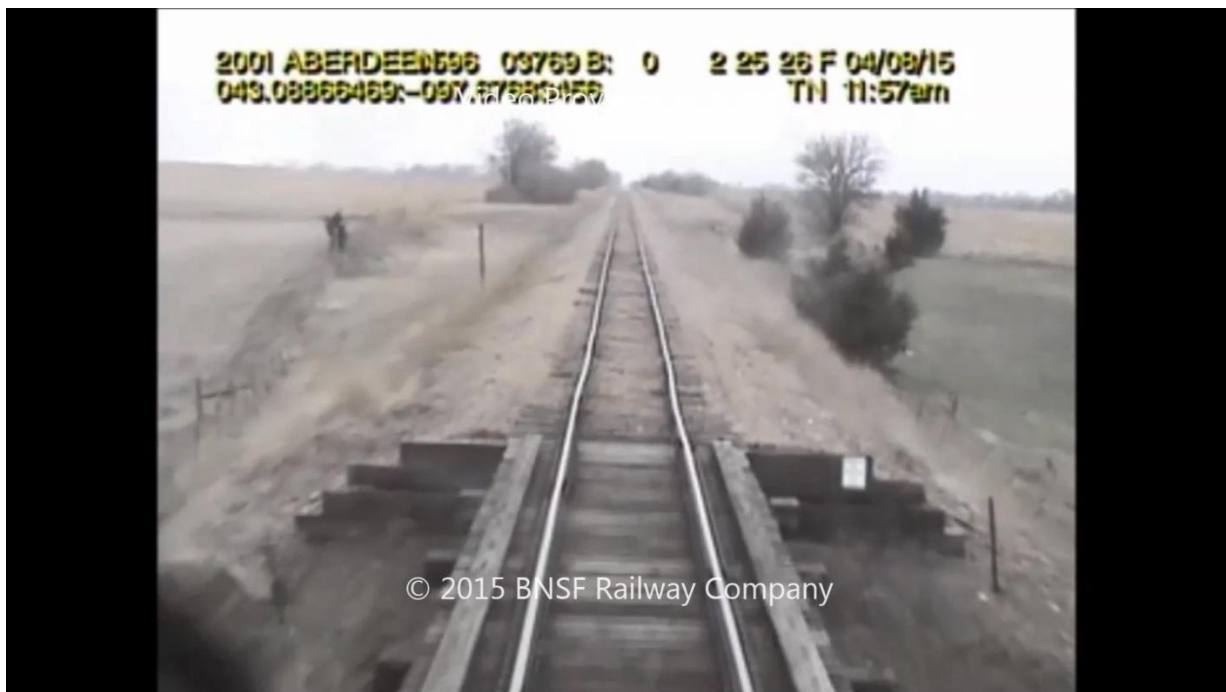
Figure 2, view from BNSF #87 geometry car rear traveling west

A previous geometry car track evaluation conducted on the Aberdeen Subdivision was done on the 04/08/2015 with the BNSF #87 car with one defect noted of a tight gage measuring 9/16 inches with a length of 15 feet. See figure 2, for a view of the east end of bridge at MP 596.68, and track taken from the geometry car. The BNSF geometry car data history identifies repeated defects found for prior evaluations. From 9/15/2014 to 9/14/2015 a tight gage repeat defect was recognized at MP 596.67 the defect was 0.58 inches for 15 feet.

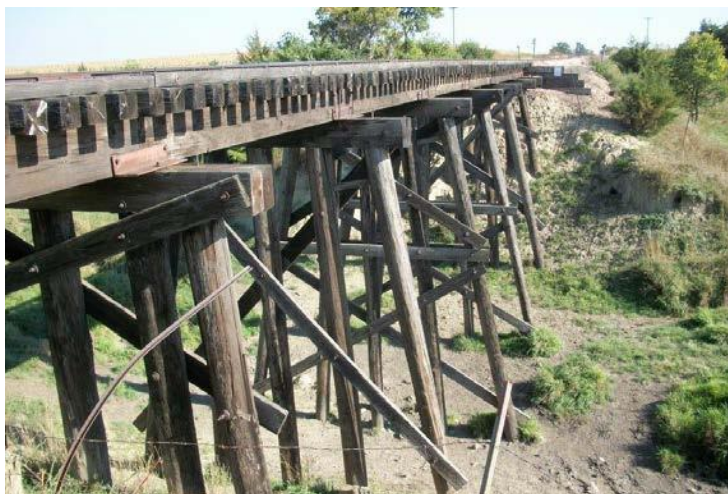
Figure 3
Bridge 596.7

- Timetable Speed was 25 mph and a 10 mph speed restriction for track surface conditions encompassed the bridge structure
- Cooper Load Rating: Normal E-60. Max Rating @ 10mph E-76 (See attachment 1 for a general description of Cooper Load Rating)

- Contracted Inspection: Osmose, 9/24/2013
- Last routine inspection: 3/23/2015 by BNSF Bridge Inspector
- Last routine inspection exception documented: Cap #1, decayed/crack. Priority level: "Maintenance" as scheduled

Exception ID number 0906131061514652 showed that substructure #1 [bent 1] the cap is decayed and cracked. The priority level is maintenance. The bridge inspector entered the exception in the data base on 03/23/2015.

The BNSF bridge inspector said that after bridge cap #2 was replaced no track surfacing work was conducted east of bridge cap #1. He said it was the track departments’ job to surface the track off the bridge. The Roadmaster said that he did not know that the bridge cap had been replaced.

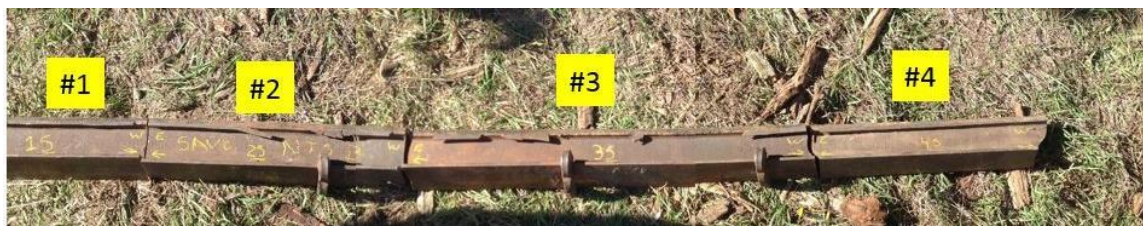
Figure 4
View of the recovered south rail segments from the area of the POD

The POD is about 10 feet east of the east bridge abutment. The POD location was determined between rail pieces #2 and #3 at GPS location 43.088584 latitude and -97.676768 longitude, or milepost (MP) 596.66. See figure 4 for a depiction of recovered broken rail with fracture faces matched.

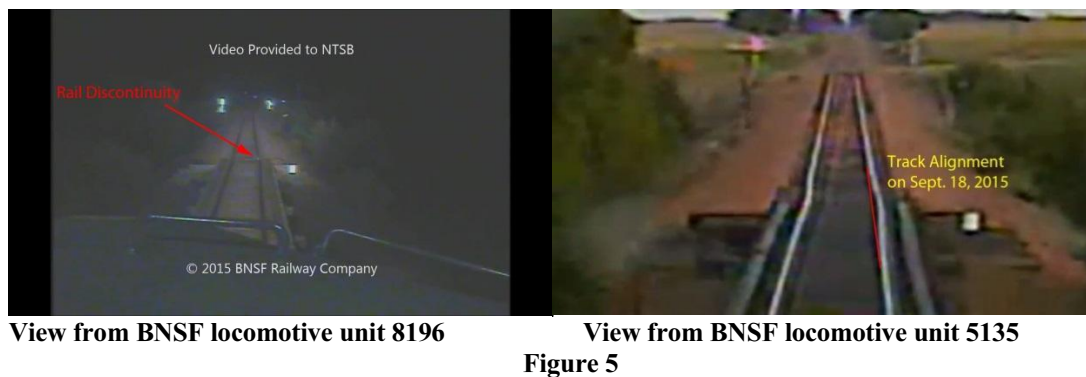
The approximate location of the POD and track alignment was verified by images recorded by the head-end videos of the two previous trains. In figure 5, BNSF train G MNSDPK7 17 with head-end video from BNSF 8196 recording near the POD at 10:37 p.m. on September 18, 2015, and BNSF train X CNBMNS9 20 with head-end video from BNSF 5135

recording near the POD at 4:07 p.m. on September 18, 2015. The train that derailed also had images recorded by the head-end video, but it was too foggy to discern any track anomalies.

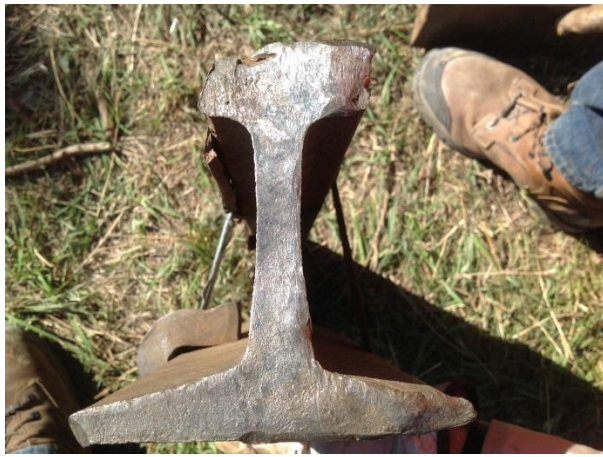
Figure 6 View of the west end of 2S

The mating fractures at the east end of piece 3S and the west end of piece 2S were examined. The fracture occurred in essentially a flat transverse plane. Fracture features were largely obliterated by friction batter, and the fracture faces generally showed a blue-black tint. Spalls intersecting the fracture surfaces were observed at the gage side of the running surface adjacent to each of the fracture faces. The spall on piece 3S was approximately 1 inch wide, 1 ¼ inches long, and 1/8 inch deep. On piece 2S, the spall intersecting the fracture surface was approximately ½ inch wide, ¼ inch long, and ¼ inch deep. No fracture features were identified on the battered surfaces to indicate fracture propagation directions or fracture mechanism. See figure 6 for a depiction of the mating surfaces of rail pieces 2S and 3S. See the Materials Laboratory Factual report for the complete details of the rail examination.

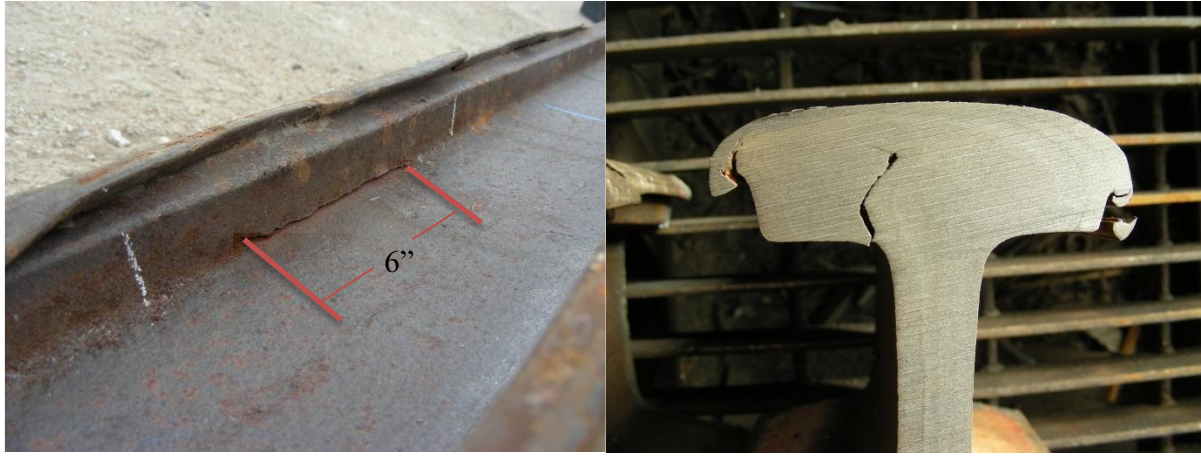
Figure 7

During the track group's investigation on September 19, 2015 between MP 596.65 and MP 598.7, railhead breakout was found on the north rail at MP 596.65 (about 250 feet east of the POD). Also at MP 596.68 there was a shelled, spalled, and corrugated (SSC) area that had been marked by a BNSF rail defect detector operator in 2013.¹⁵ At some point this SSC developed a 6 inch vertical split head on the field side of the rail head. With the 10 mph speed restriction that was already in place, this defect is compliant with the FRA *Track Safety Standards* Part 213.113, and can stay in track. However, the BNSF removed the rail defect and sectioned it. See figure 7, and note that the crack did not propagate through the entire rail head.

View of the crack under the ball of the rail and a cross-section view after the rail was sawed
